existing condition

construction

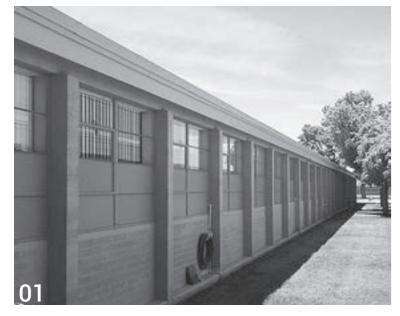
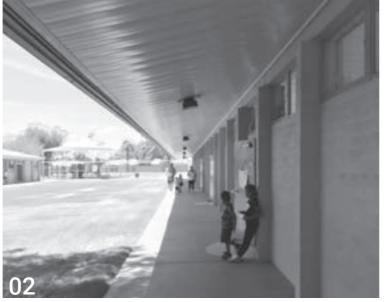
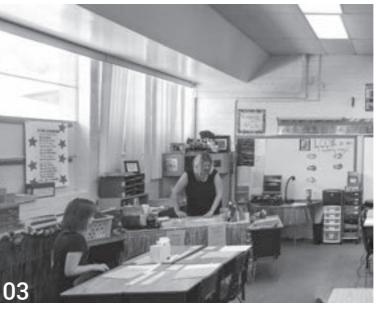
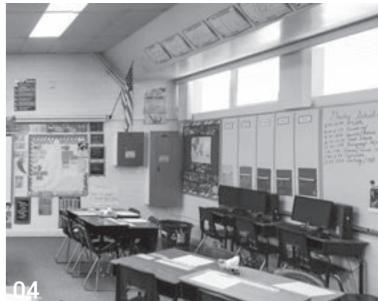
- High, single-pane, energy-inefficient windows along the classroom buildings' north facades limit daylight and prohibit views outside. These windows are inoperable, as well, preventing natural breezes.
- Pigh windows along the south facades are also inoperable, preventing natural ventilation and requiring massive amounts of mechanical heating and cooling throughout the school year (a large expense for the school district). Space between buildings is under-utilized with little shade (a key component in the Arizona desert where temperatures can reach 120°).
- The interior of the classroom contains low, dropped ceilings with fluorescent lights that are always on to compensate for ineffective daylighting. No views out are prohibited. Vertical blinds are the only means of controlling daylight.
- **04** The classroom space is cluttered and lacks efficient storage space.

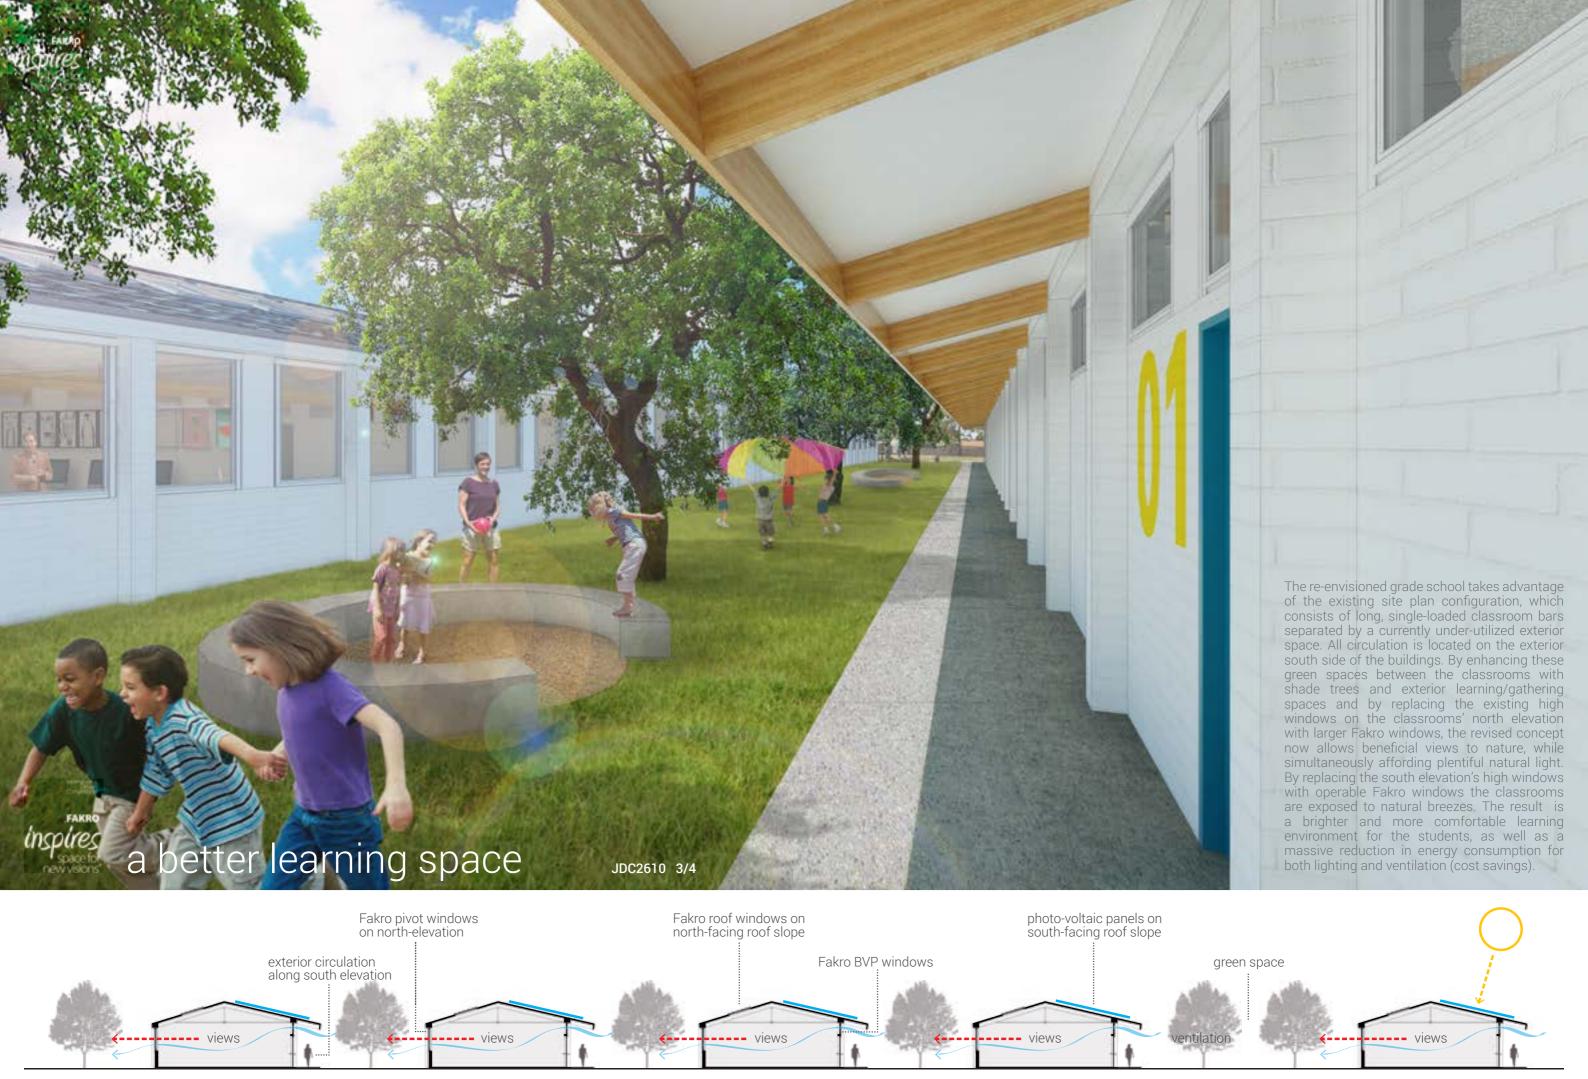
photo-voltaic panels on southfacing roof slope Fakro PYP-V proSky roof window w/ external AMZ Solar shades on north-facing roof new roofing w/ improved thermal insulation new roof framing, including exposed king-post trusses Tectum acoustic ceiling panels existing brick envelope, updated w/ fresh white paint Fakro BVP L3 windows w/ Fakro ARP-E internal shades Fakro PYP-V windows w/ ARP-E remote internal shades a better learning space JDC2610 4/4

The renovation strategy takes advantage of the school's solid brick structure, maintaining all walls in order to reduce unnecessary costs. The walls are, however, given a simple coat of white paint to brighten up both the exterior and the interior. The bright white interior walls allow daylight to bounce and illuminate the entire space.

The aging roof structure, however, is removed, along with the suffocating drop tile ceiling. New king-post trusses are added, becoming an architectural feature within the classrooms and allowing the students the opportunity to see/understand how a building's structure works. New roofing with additional insulation replaces the existing batt insulation. On the interior Tectum acoustic ceilings panels provide the ceiling finish and help reduce noise reverberation. Punched openings along the north face of the new roof provide space for Fakro PYP-V proSky roof windows. The north face is used in this desert climate to reduce direct sunlight entering the classroom and heating the space. Winter temperatures are mild and heating is rarely necessary. External Fakro AMZ solar shades further reduce heat gain, if necessary, and provide the teacher with a means to control interior lighting levels via remote control. In many cases, darkening of the room is desirable for showing educational films. Photo-voltaic panels are added along the south-facing slope of the roof to further reduce energy costs for the school district.

All windows on the existing classroom buildings are removed. The larger windows on the north facades are replaced with Fakro PYP-V proSky roof windows that occupy the full opening in the brick wall. The previous window units had steel panels covering the lower portion to prevent views out by the students. The high windows along the south facade are replaced by Fakro BVP L3 windows. Fakro ARP-E internal window shades give the teacher the ability to reduce light levels remotely.

01 Fakro ARP-E internal shades and Fakro AMZ external Solar shades provide a means for the teacher to control the amount of natural daylight entering the space. In this case, the classroom is essentially blacked out to allow for a film to be viewed. Note that increased built-in storage space allows for a more flexible space. Desks can be pushed to the back of the classroom to free up floor space.
